PATTERSON CREEK (RM 0.0–10.1), AUGUST 14–15, AUGUST 19–21, AND AUGUST 27, 2002

CANYON CREEK (RM 0.0–2.0), AUGUST 20–21, 2002

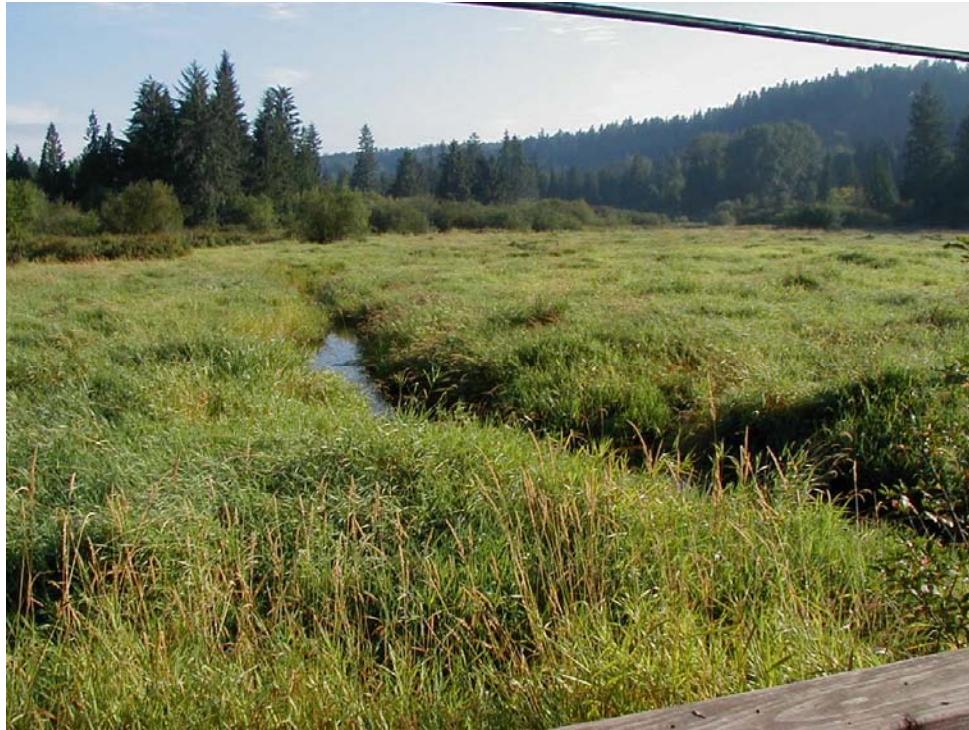
Patterson Creek followed SR 202, flowing within 100 feet of the roadway throughout this reach. The creek was straight and deeply entrenched (Photo PA1). The substrate was predominantly silt with patches of gravel and pebble. The shallowest water was only 2.9 feet in depth; in other locations the water was too deep to measure. At RM 2.9 the flow was subsurface. The wetted width was approximately 10 feet, and the OHW was 24 feet wide.

Photo PA1. Patterson Creek floodplain.

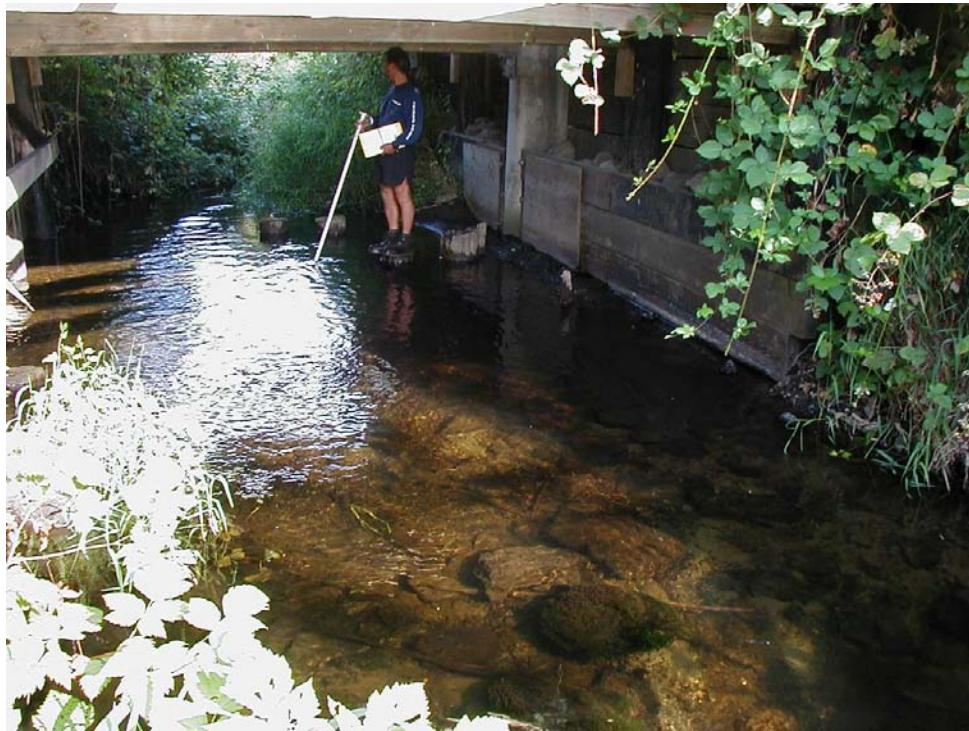
There are road crossings at RM 2.2, 2.5, and 2.9 (Photo PA2). A culvert on the RB at the Duthie Hill Road crossing (RM 2.5) had water that was noted as “very cold, aches to walk in.” This was likely groundwater seeping into Patterson Creek.

Photo PA2. Road crossing at RM 2.9.

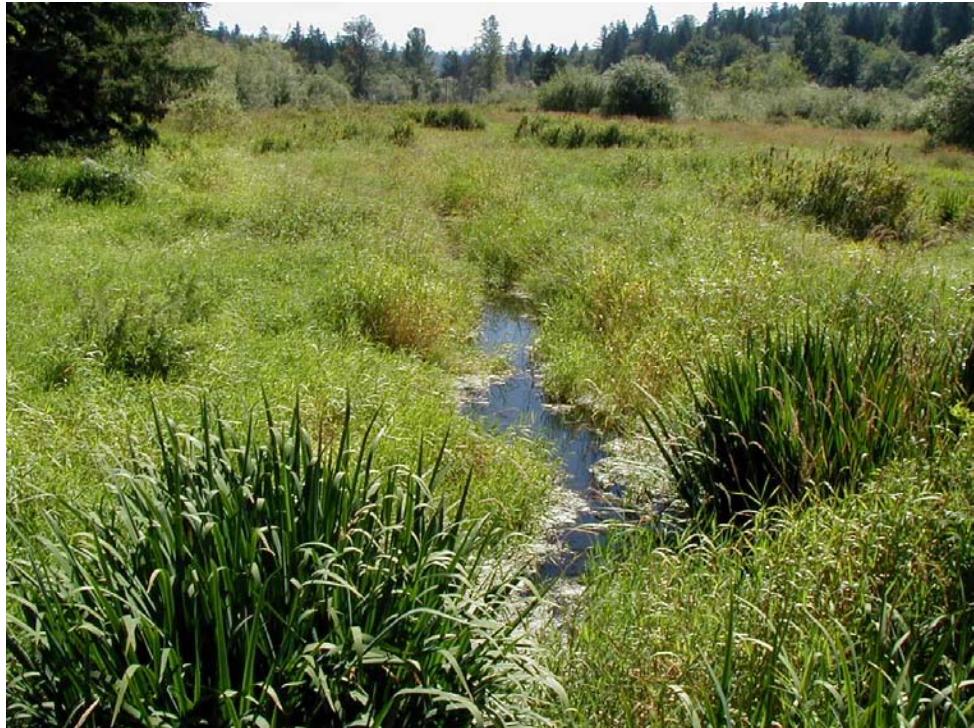
The wetted width of the creek was 4–6 feet. The water depth varied from 6 inches to as much as 5 feet (Photo PA3). Silt dominated the substrate.

Photo PA3. Reed canary grass dominates the Patterson Creek floodplain, RM 6.9.

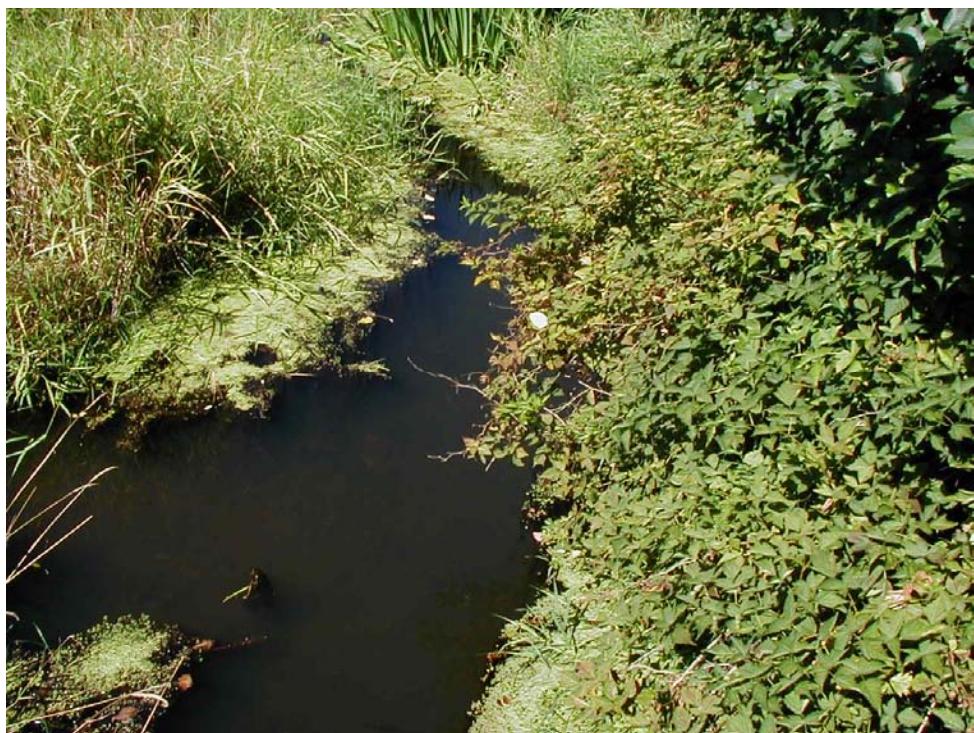
Invasive plants, especially reed canary grass and yellow iris (Photos PA4–PA5), were very dense in this reach of Patterson Creek. Some willows were observed, but very few native plants existed. LWD was absent. Nevertheless, coho fry were observed throughout the reach.

Photo PA4. Invasive plants choke Patterson Creek at RM 6.9.

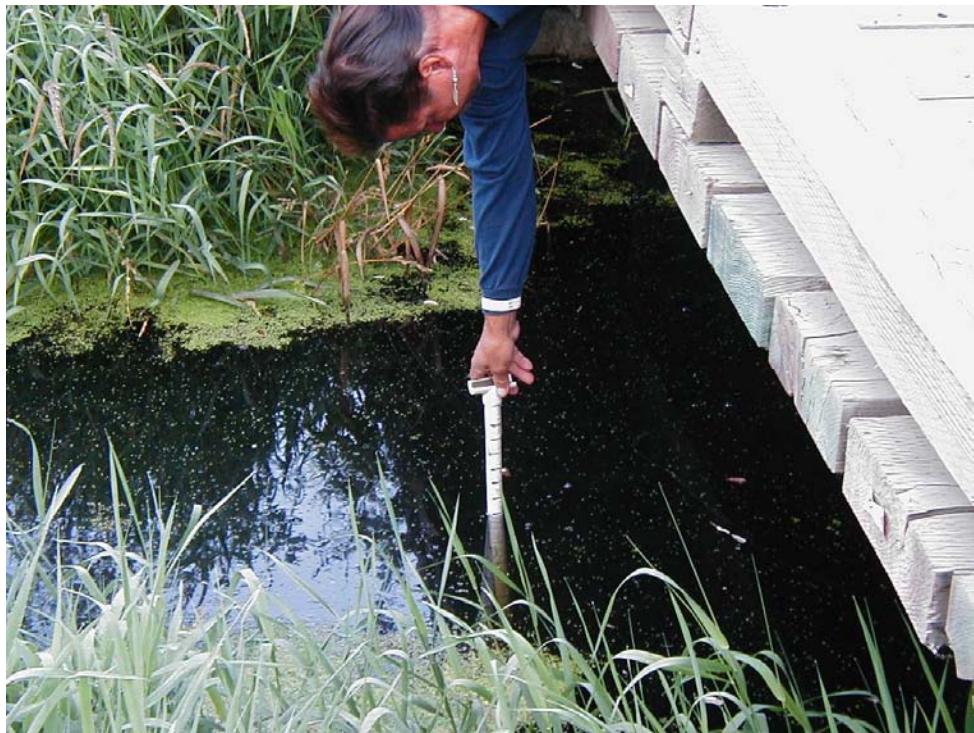
Photo PA5. Deep pool at RM 5.0.

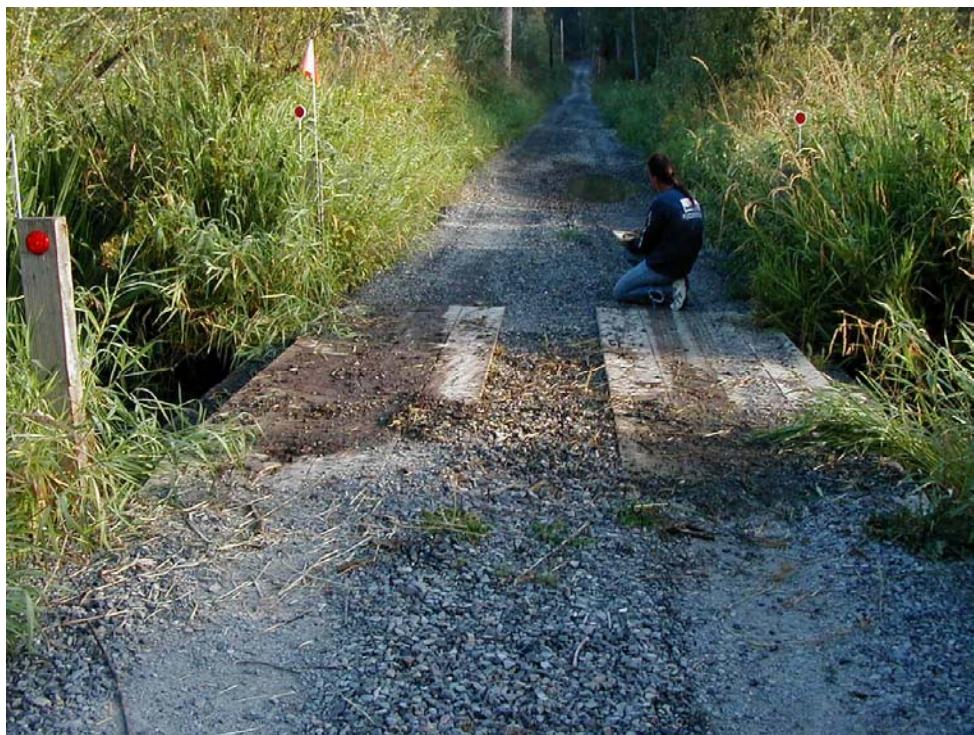
There were six road crossings in this reach, at RM 4.2, 4.6, 5.0, 5.8 (Photo PA6), 6.5, and 6.9.

Photo PA6. Road crossing at RM 5.8.

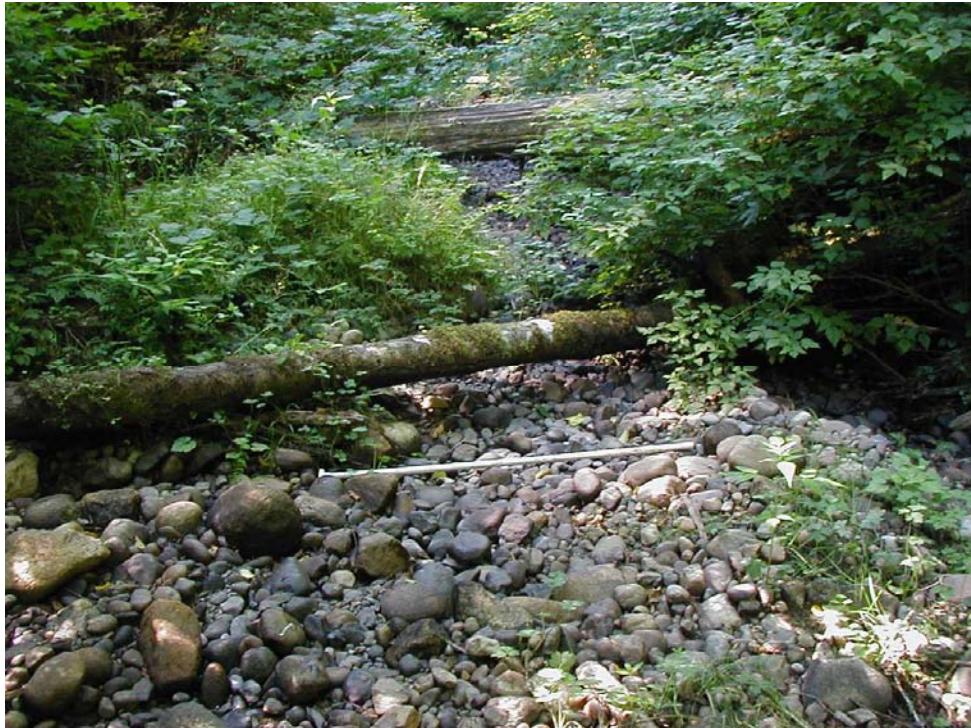
In this upper reach, Patterson Creek flowed through residential land with a gradient of 2–5%. Flow was subsurface at times (Photo PA7). Land development in this area had forced the creek through several culverts, some of them perched, as roads crossed the creek.

Photo PA7. Sub-surface flow at RM 8.9

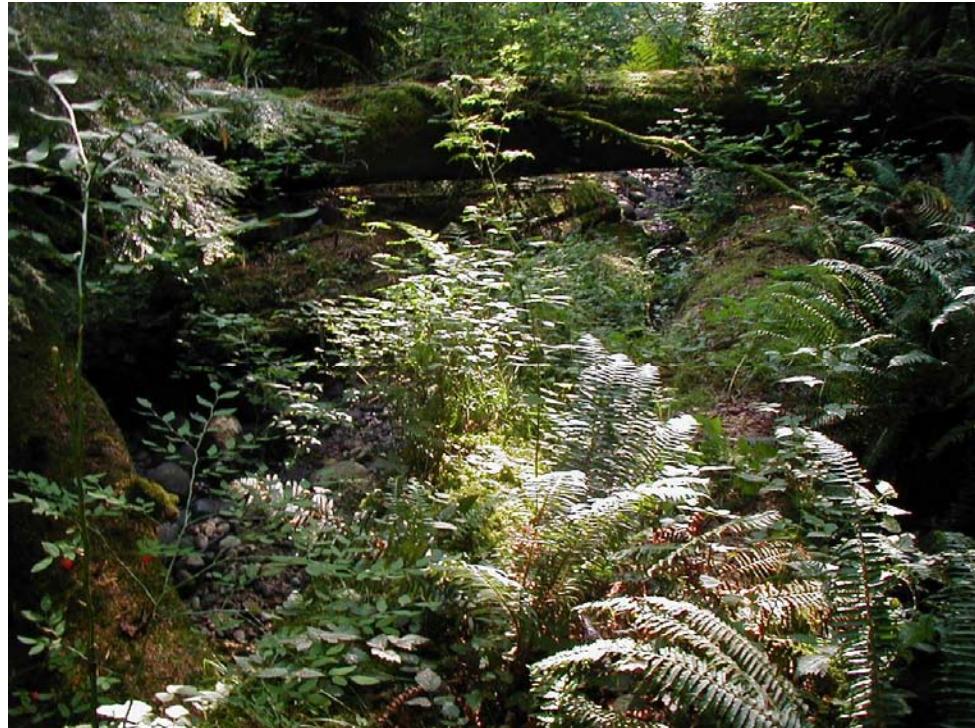
With the exception of occasional blocked culverts and some water withdrawal pumps, this reach was described as looking “very healthy and natural” (Photo PA8). LWD was abundant.

Photo PA8. Healthy riparian vegetation at RM 9.4.

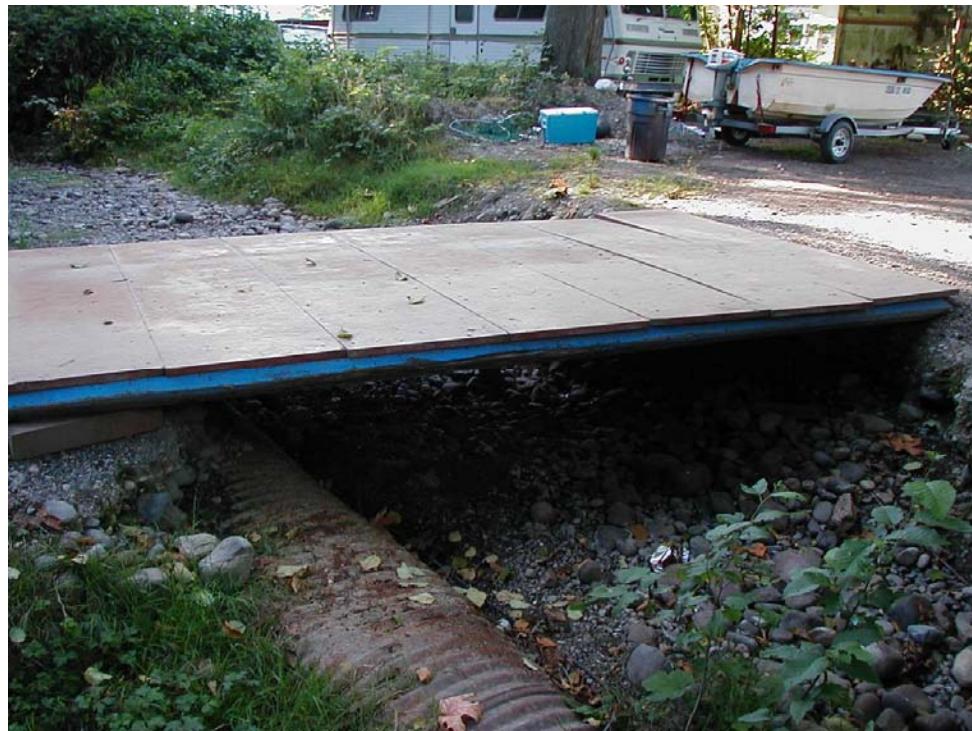
Residents at a house at RM 8.6 explained that their driveway over Patterson Creek was washed out recently when the culvert underneath it plugged up. They had installed a temporary bridge and were waiting for the permits to install a permanent bridge (Photo PA9). A 60-foot-long blown-out culvert was resting in the creek at RM 9 (Photo PA10); the original location of this culvert was unclear. A perched culvert at RM 9.7 was a barrier to coho fry migration. A plunge pool at the downstream end of this culvert was 15 feet long and 9 feet wide. This was the only pool observed in this uppermost reach of Patterson Creek.

Photo PA9. Temporary bridge over driveway at RM 8.6.

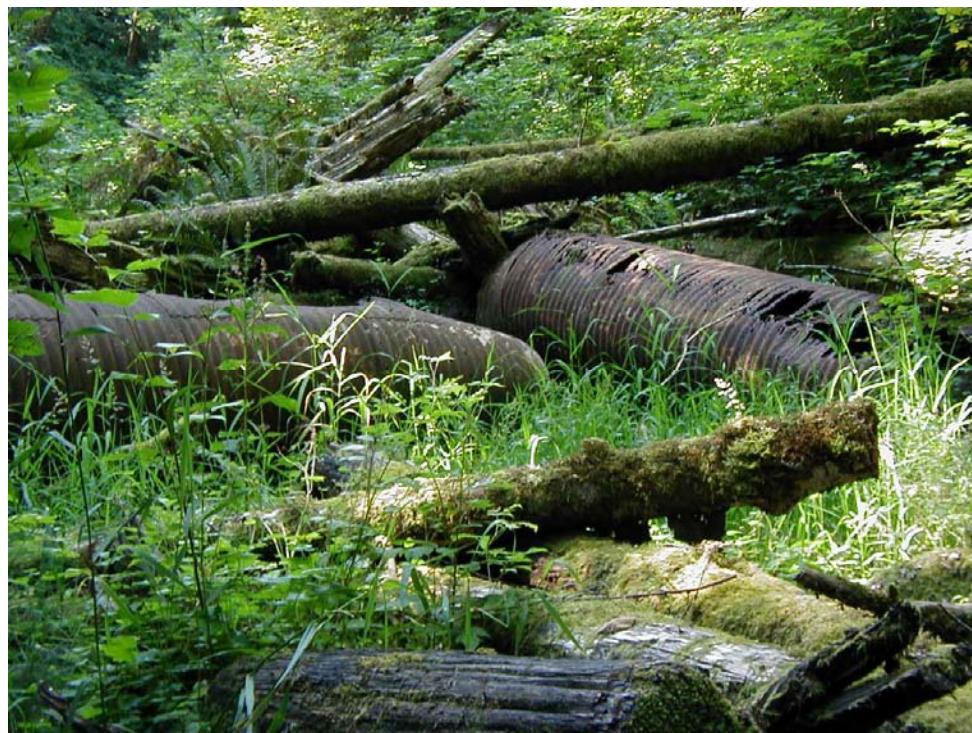
Photo PA10. Old culvert rotting in the creek, RM 9.4.

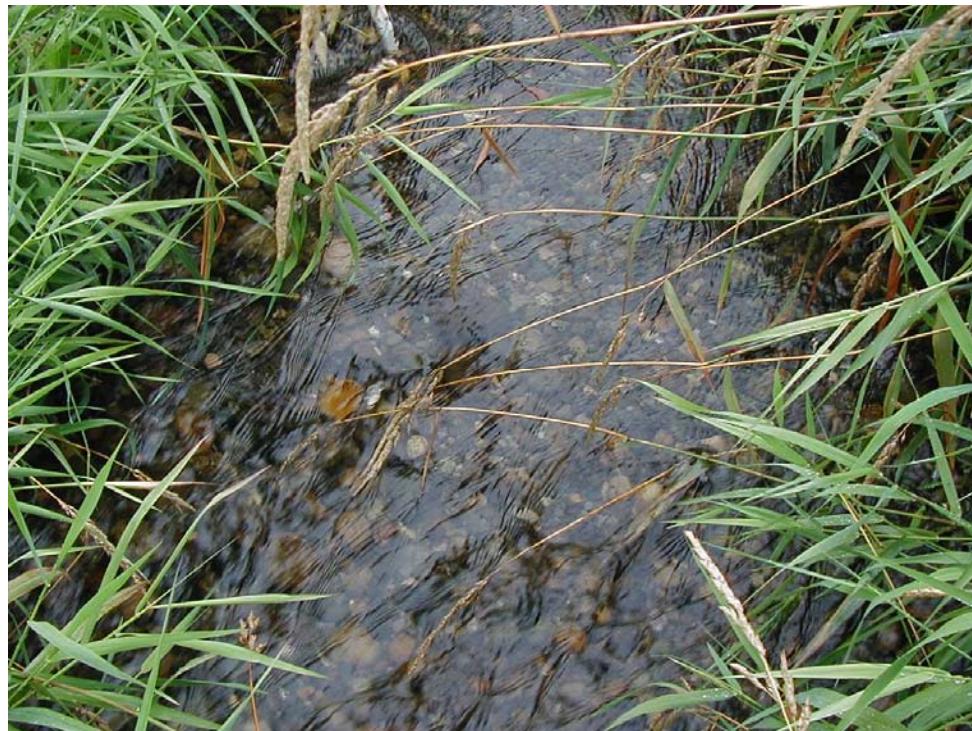
The streambed morphology in this lower reach was riffle/glide and the wetted width was 8–10 feet with a 24-foot OHW. Two deep pools were observed in this reach. The substrate was pebble and gravel of good quality for coho spawning (Photo CA1).

Photo CA1. Spawning gravel, RM 0.1.

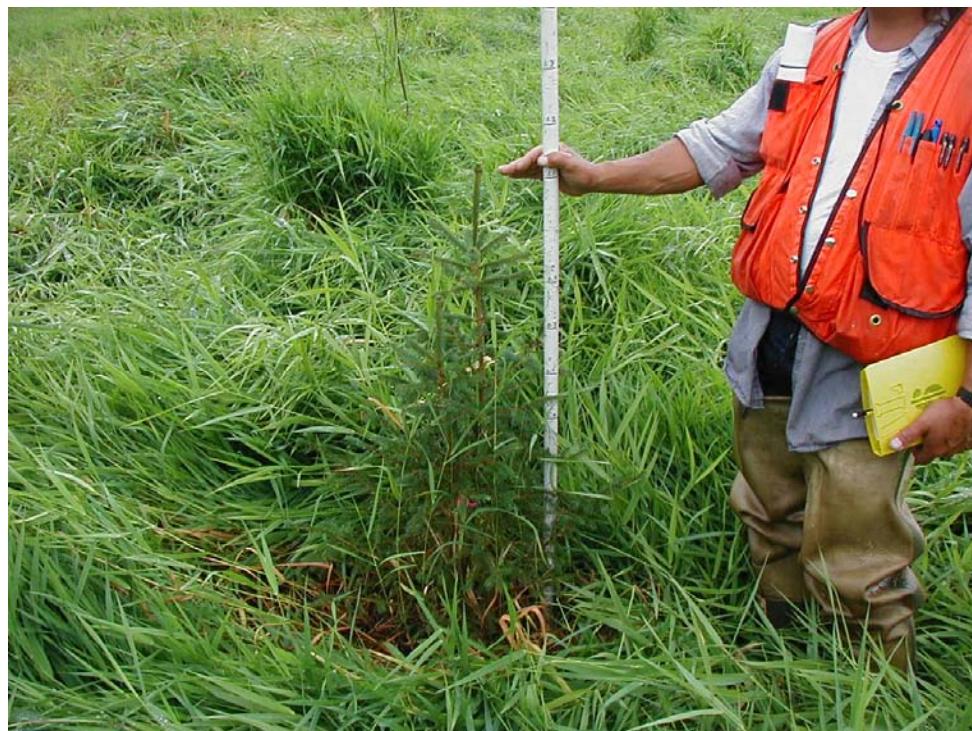
However, Patterson Creek's invasive weeds inundated Canyon Creek (Photo CA2). The riparian vegetation was exclusively reed canary grass and blackberry, except for some restoration plantings at RM 0.1. Because of the degraded riparian vegetation, the overall habitat quality was rated as poor (see Table 1 in the Conclusions Section).

Photo CA2. Reed canary grass in Canyon Creek, RM 0.1.

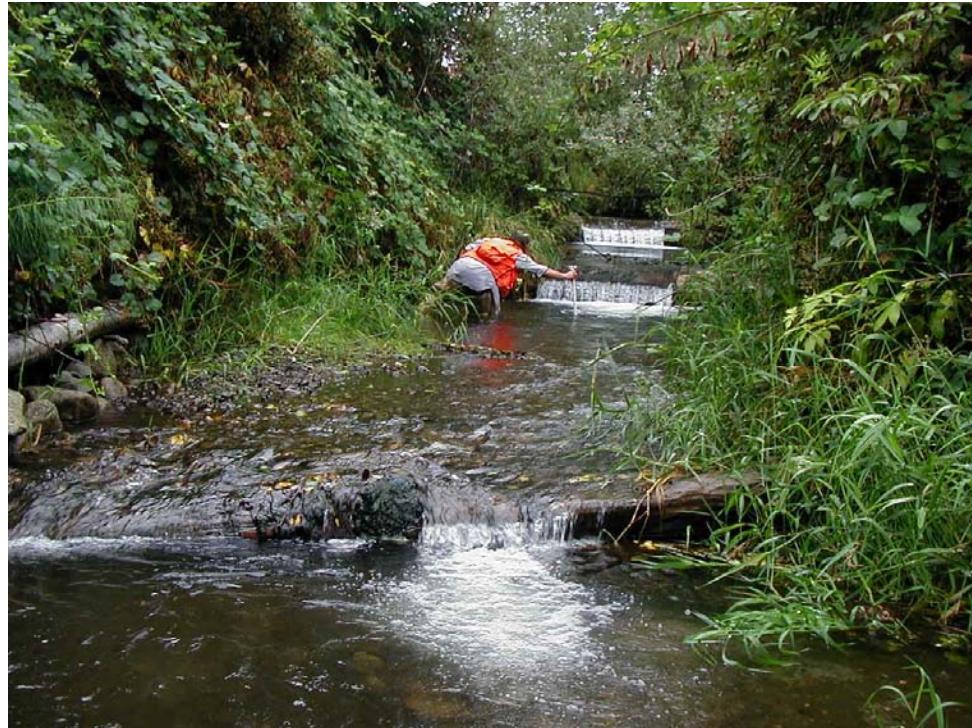
Canyon Creek flowed through a golf course between RM 0.2–0.6. A LB tributary that flows through the golf course at RM 0.2 was dry; an old redd was noted at RM 0.2. Bridges for golf carts crossed the stream at RM 0.2 and 0.3, and twice at RM 0.4. Fish ladders were observed at RM 0.4 and 0.5 (Photo PA3).

Photo CA3. Fish ladder at RM 0.4.

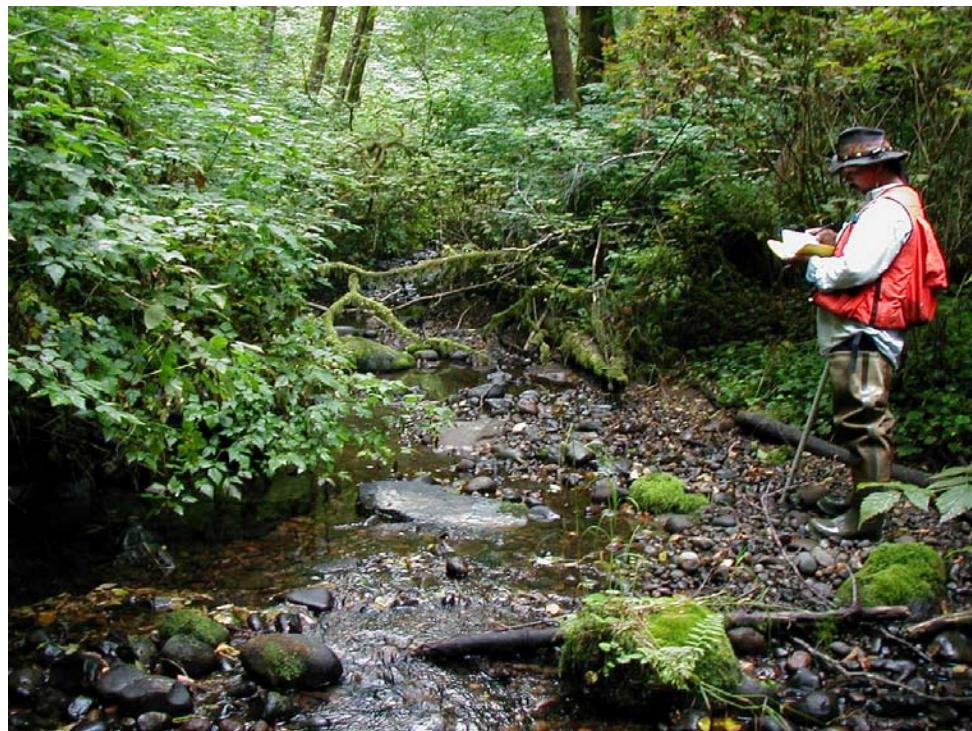
Canyon Creek flowed through a steep canyon with abundant wildlife, coho fry, and trout. Reed canary grass was observed up to RM 0.7, but only in sparse quantities. The riparian shrubs through this reach were salmonberry, vine maple and devils club. The canopy was closed throughout this reach and was mostly alder with some maples. Overall, the riparian vegetation in this reach was excellent (Photo CA4).

Photo CA4. Healthy riparian vegetation at RM 1.5.

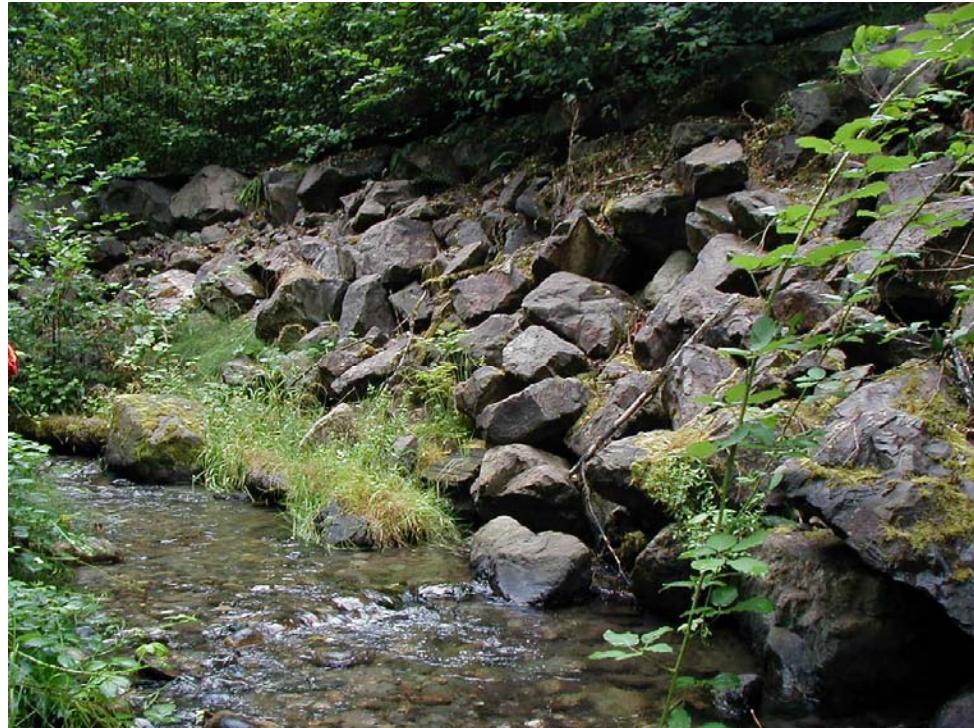
Riprap along the LB at RM 0.8 was protecting an old logging road (Photo CA5). Bear tracks were observed on the RB at RM 1.3. The presence of a silt fence along the LB at RM 1.3 indicated that land development and/or logging activity were occurring in the basin (Photo CA6). Just upstream of the silt fence was a wooden footbridge (Photo CA7). Some stream braiding at RM 1.4 had built up gravel bars.

Photo CA5. Rip rap at RM 0.8.

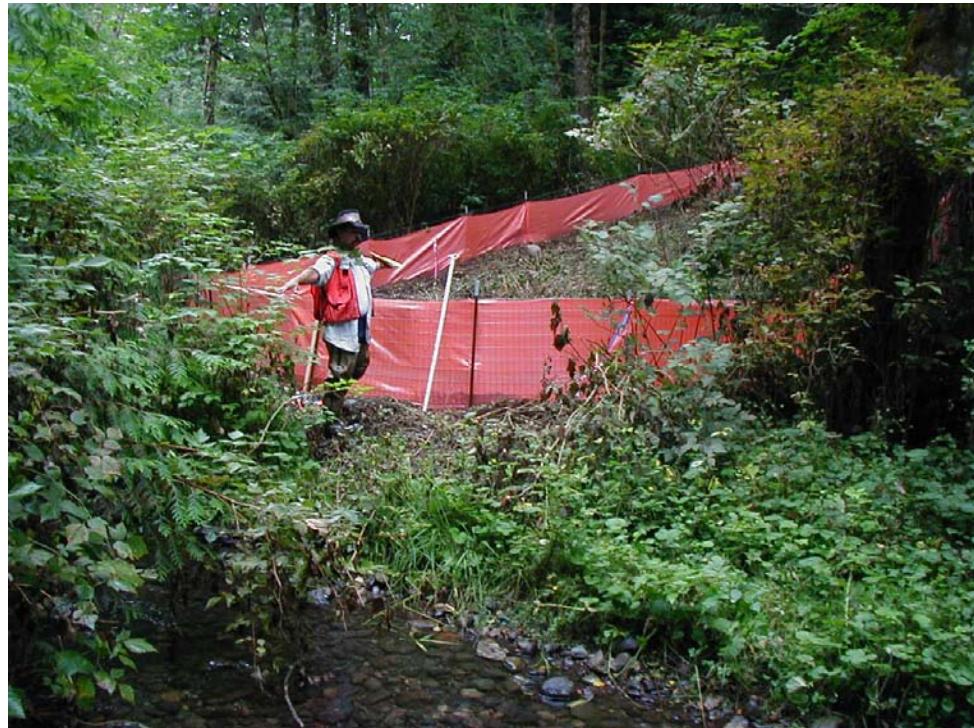
Photo CA6. Silt fence, RM 1.3.

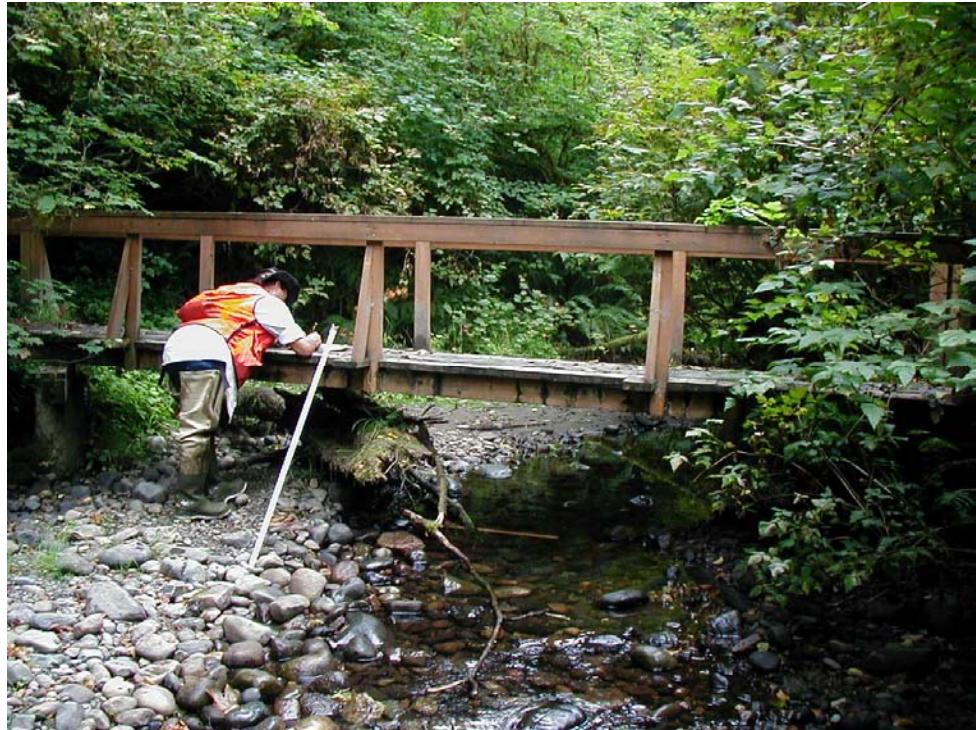
Photo CA7. Foot bridge, RM 1.3.

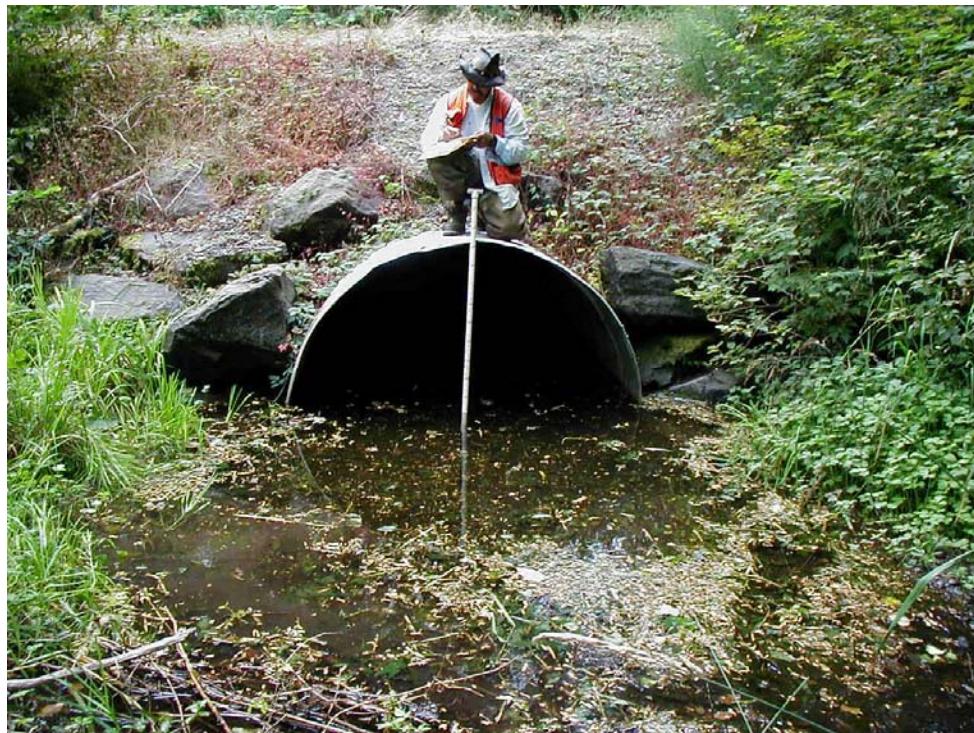
Some clay hardpan was noted in the RB at RM 1.5 and 1.7, indicating stream scour during high flow events. At RM 2.0, Canyon Creek flows under SE Issaquah-Fall City Road (Photo CA8). Many coho fry were observed in the pool under this culvert.

Photo CA8. Culvert under SE Issaquah-Fall City Rd, RM 2.0.
